Cost and Energy Savings for a Factory Building after Modernizing the Heating System

*F. Pinno, K.-P. Möllmann, and M. Vollmer,
University of Applied Sciences, Brandenburg, Germany*

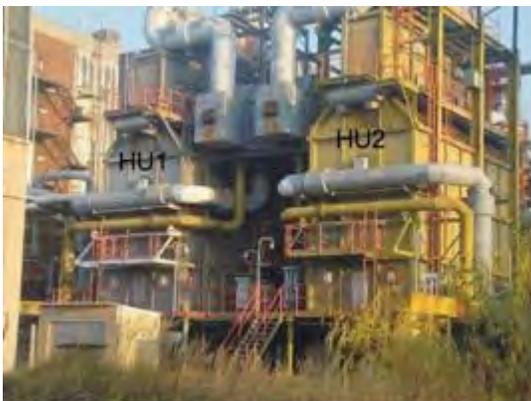
As reported earlier, the production of chemical fibers is an energy-intensive process. The necessary energy in the plant under study was provided by two big identical heating units HU1 and HU2 (Figure 1a), which use gas burners and liquid diphyll as a heat transfer medium [3]. After heat insulation problems were detected [1], it was determined that in the first phase, only heating unit HU1 should be modernized.

Figure 1a. Overview of the two heating units (HU1,2), left unit (HU1) with new thermal insulation

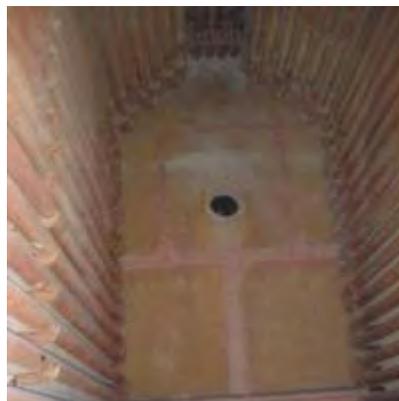
Figure 1b. Inner part of the heating unit (HU1), new ceramic insulating plates were attached to the walls

In the inner part of the gas burner (Figure 1b) new ceramic insulating plates were attached to the walls. This thermal insulation material with thickness of 25 mm has a low thermal conductivity of 0.09 W/m·K, at an average operating temperature of the plate of 250°C. The temperature in the inner part of the HU1 is typically around 470 °C. The thermal conductivity of the ceramic plates at this operating temperature is higher than 0.09 W/m·K; the exact value is, however, unknown. The repair work was done while downsetting the unit during the regular annual inspection period of about two weeks. The repair costs amounted to 56,000 €, (approximately \$73,000).

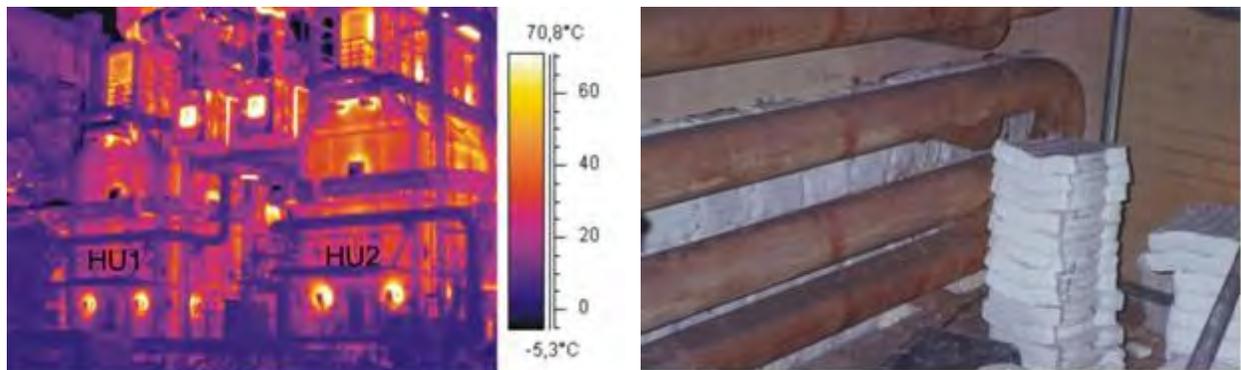
To make the first qualitative estimate for successful repair work, it is necessary to compare the thermal signatures of two previously identical units. Figure 2 depicts IR-images, recorded with a LW camera (ThermaCam SC2000). While this image was taken, HU1 was operating at a thermal power 3.5 MW_{th} whereas HU2 only at 2.7 MW_{th}. If both units behaved identical, one would obviously expect the HU1 outside walls to be warmer than those of HU2. However, the opposite occurred. Although operating at about 30% more power than HU2, HU1 showed lower thermal losses, i.e. the repair work was indeed very successful.

Figure 2. IR-image of both heating units (left: HU1 with new insulating plates inside, right: HU2 not insulated)

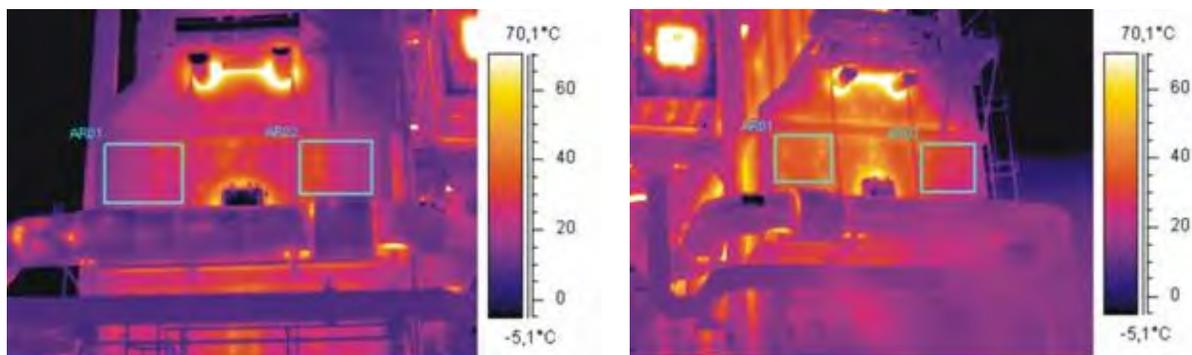
A quantitative comparison is shown in Figure 3. Areas AR01 and AR02 were analyzed at about the same observation angles and revealed temperature decreases between 3.7 to 15.5 K. A quantitative analysis of the energy savings proves difficult, however, due to the difference of the two operating thermal powers. For this reason, it proved necessary to make a direct comparison of HU1 before and after repair.

Figure 3. Enlarged sections (AR01, AR02) as indicated in Figure 2 of the front section of HU1 (left) and of the front section of HU2 (right).

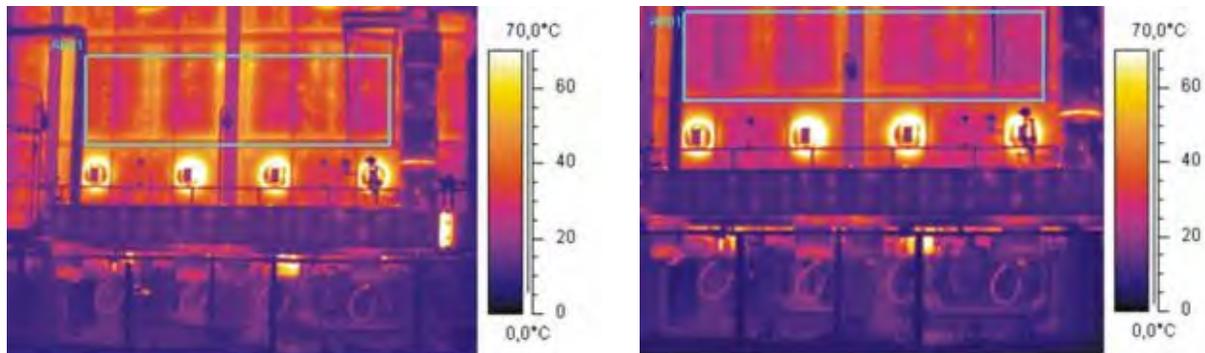
A detailed quantitative analysis was completed by comparing measurement of HU1 before and after repair (Figure 4). The images were recorded at the end of November 2005 (before) and beginning of December 2006 (after) for comparable operating conditions at $P_{th} = 3.5$ MW and similar ambient temperature around 5°C (left) and 2°C (right). Figure 4 shows such views of HU1, plotted for the same temperature range. The analysis area AR01 revealed average temperatures of 36°C before and 29°C after repair. This decrease is mostly due to the new thermal insulation and only partly due to the slightly higher ambient temperature after repair.

Figure 4. Side view of HU1 before repair work (left) and after repair (right) with the same analysis area AR01. Average temperatures were found to be 36°C (left) and 29°C (right).

A quantitative measurement of the heat flux was made with a heat flux plate [1]. Before repair work, a heat flux of only 250 W/m² was measured. After the repair, a reduction by 80 W/m² led to much lower heat flux of only 170 W/m². Obviously, the exact value depends on the ambient temperature and wind speed [4], and seasonal variations are expected.

The outer surface area of the heating unit amounted to about 240 m². Using an 80 W/m² reduction in heat flux, the reduction in thermal loss power amounts to $P_{\text{reduction loss}} = 19.2$ kW with an annual cost savings of

Regarding the costs of 56,000 €, amortization will take 10 years at current gas prices. This period may become smaller if gas prices continue to rise. The repair company predicted 3 years. Presently they plan to modernize heating unit HU2 during the next regular inspection period.

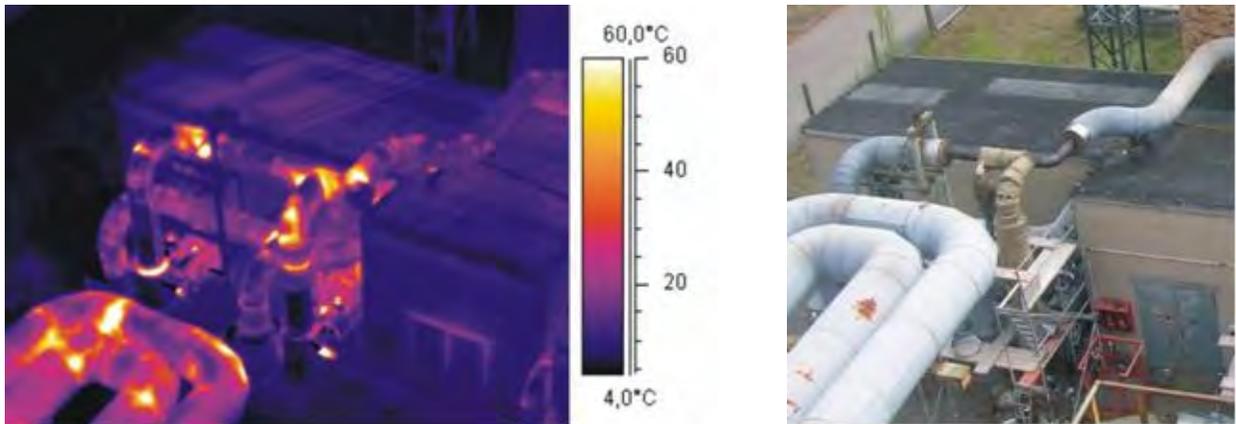
Figure 5 (left) illustrates appreciable heat leakages in the upper part of the outer pipe system, whereas thermal losses in the lower part of the valve were low. The right visible image of Figure 5 shows the system with new thermal insulation.

Figure 5. Thermal insulation leak in the pipe system close to the pumping station (left) and visible image of the new insulated pipes after repair work (right).

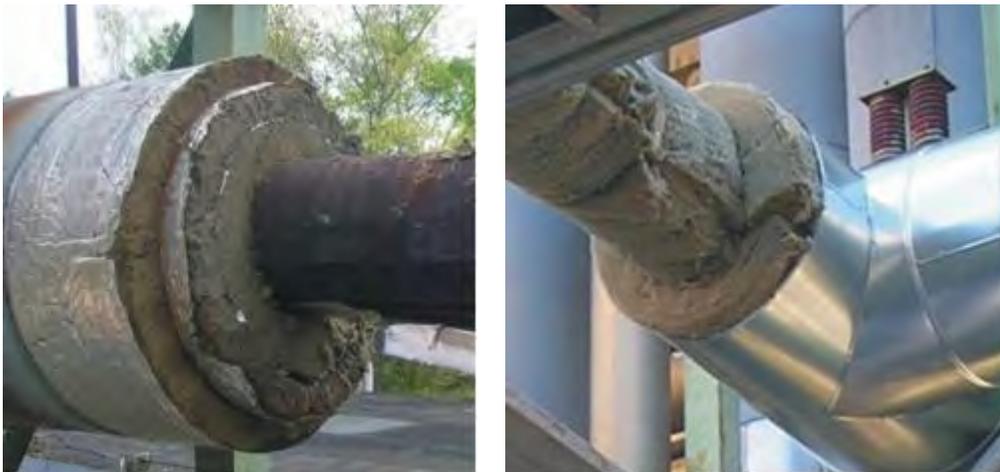
The new thermal insulation (expanded view Figure 6, right) does not need aluminium lamination like the old insulation (Figure 6, left). A direct comparison of old and new insulation is depicted in Figure 7 (left), in the vicinity of the pumping house. Obviously, the old insulation in Figure 7 (right) was rotten and wet, which led to increased thermal conductivity of the material. Unfortunately, such wet insulation cannot be easily identified with IR-imaging without destroying the system (see wet surfaces [6, 7] since they are covered by the metal hosing of the pipe). The insulation leak detected during inspection may have been caused by a number of different factors, such as shifted insulation mats, wet insulation mats, direct leaks through small holes in the tube, bad construction of the housing with connections of the tube to outer housing, etc. The company estimates that the repair work of the pipe system close to the pumping station leads to a reduction of gas consumption by 2m³/hour. Using a current gas price of about 38.5 ct/m³ (3.5 ct/kWh corresponds to about ~11 kWh/m³), this reduction corresponds to annual cost savings of about 2 m³/h x 8,400 h/a x 0.385 €/m³ ≈ 6,500 €/a.

Figure 6. Old (left) and new (right) thermal insulation of pipe system close to pumping station.

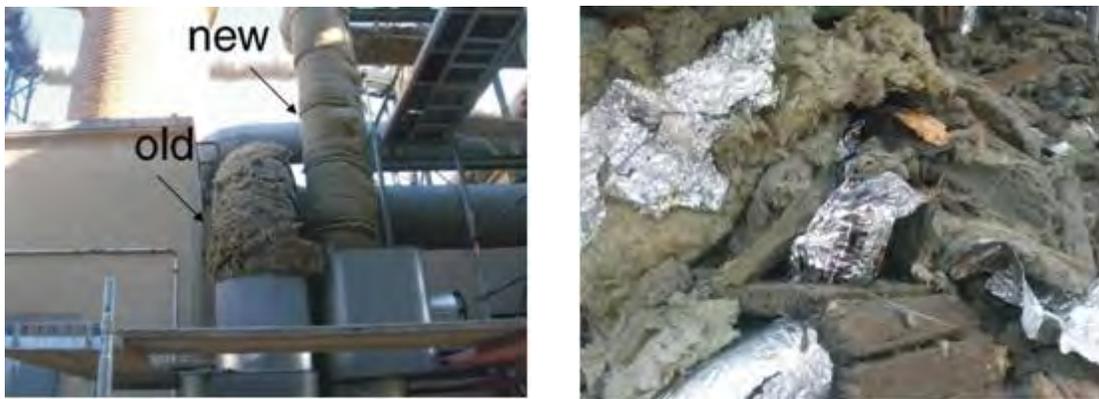
Figure 7. Direct comparison of old and new insulation of pipe system (left) and expanded view of old, wet and rotten insulation mats (right).

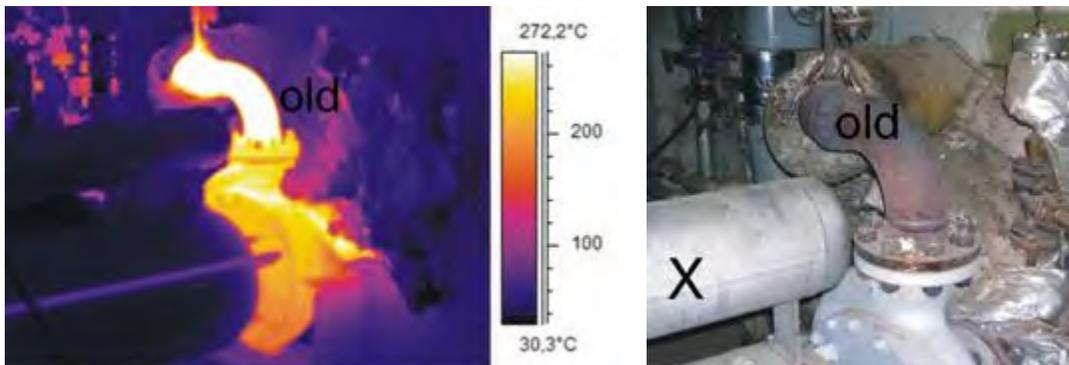
As previously reported [1], there were also four faulty or even non-insulated pumps in the pumping station (see Figure 8 [1]), with surface temperatures above 340°C! This led to enormous heat losses. As a result of the previous IR analysis, all 4 pumps were getting insulated with thermal insulation mats covered by an aluminum housing (see Figure 9). As a result of the repair work, the room temperature in the pumping house dropped from 30°C to 15°C during winter. The correlated drop on gas consumption was estimated by the company to be around 4 m³/h, leading to annual savings of about 13,000 €. Comparison to the repair costs of about 20,000 € for insulation of the pumps and the tubes outside of the pumping house, the annual total savings of 13,000 € + 6,500 € = 19,500 € corresponds to an amortization time of only about 12 months.

Figure 8. Missing insulation at a pump results in surface temperatures above 340°C [1].

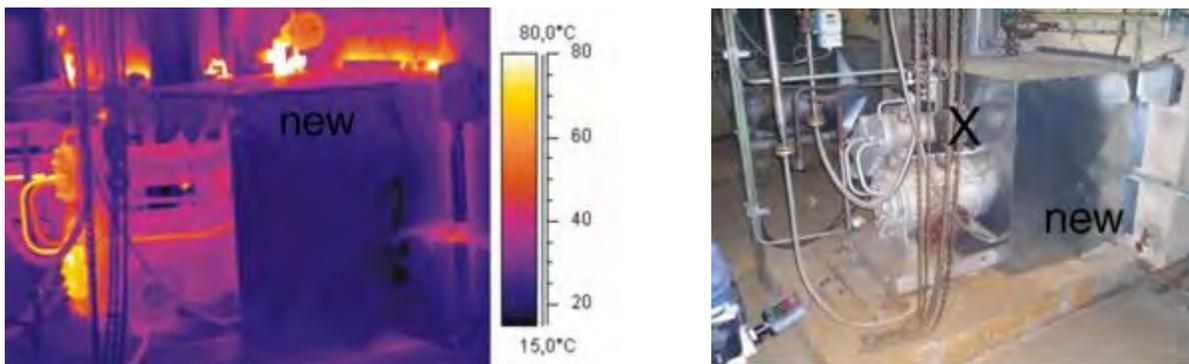
Figure 9. Example of the new insulation of a pump (right). The IR image revealed a strong reduction in heat loss (left). The marked spots in the visible image refer to the same location.

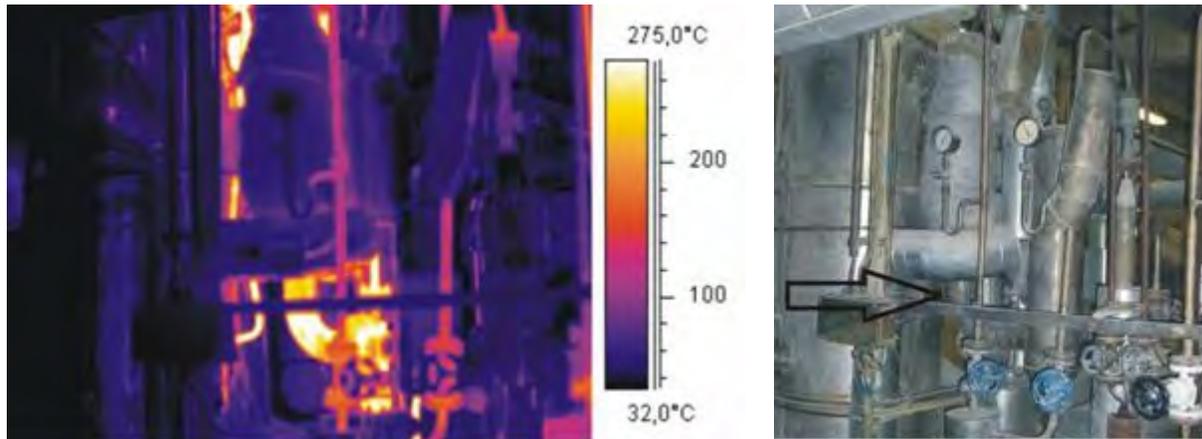
The necessity of post-repair thermal imaging analysis is nicely demonstrated by Figure 10. Within the production hall, the tube system close to a steam radiator was covered with new thermal insulation. However, the insulation at an already covered part of a tube was pushed upward for additional work and never was brought back to its original position. Consequently, part of a tube showed surface temperatures above 270°C. The IR analysis quickly helped to identify and solve the problem.

Figure 10. The new thermal insulation on a tube was pushed upward during repair work and forgotten afterwards. Thermography quickly identifies the problem, emphasizing the importance of post repair inspections.
